## Poster-Session

### Exceptionally high in-air stability of transparent conductive oxide SnO<sub>2</sub>:Ta

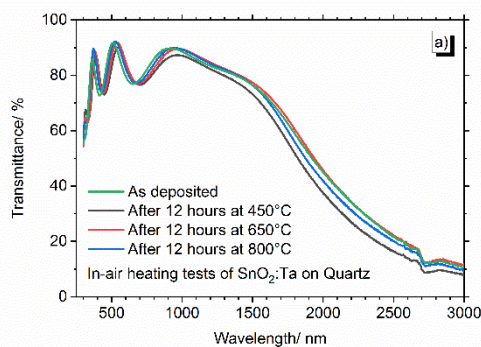
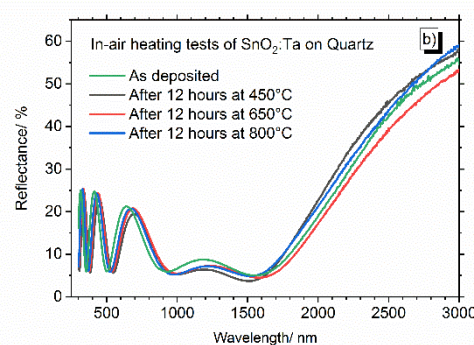
The in-air-stability of the transparent conductive oxide SnO<sub>2</sub>:Ta (TTO) thin films at 650 °C and 800 °C is studied under lab oven and solar furnace conditions. The optical spectra after the treatments were unchanged (Figure), and the X-ray diffractograms revealed the conservation of a single-phase rutile-type crystal structure. Strong Raman lines out of the phonon range of SnO<sub>2</sub> were assigned the Sn vacancy- and O interstitial-type point defects based on experimental spectra and ab initio calculations of pristine and Ta-doped SnO<sub>2</sub>. These defects were partially healed during high-temperature exposure, without affecting the optical properties of TTO under these harsh conditions. The study provides a comprehensive understanding of crystal and defect structure of TTO prior to and after high temperature treatment in air for the first time and encourages its application in different fields where transparent conductive oxides with high-temperature and oxidation stability are required.
